Potable Water System Microscopic Particulate Analysis

Cache Bar Boat Ramp

Salmon-Challis National Forest

Walsh Project Number: 6137-010

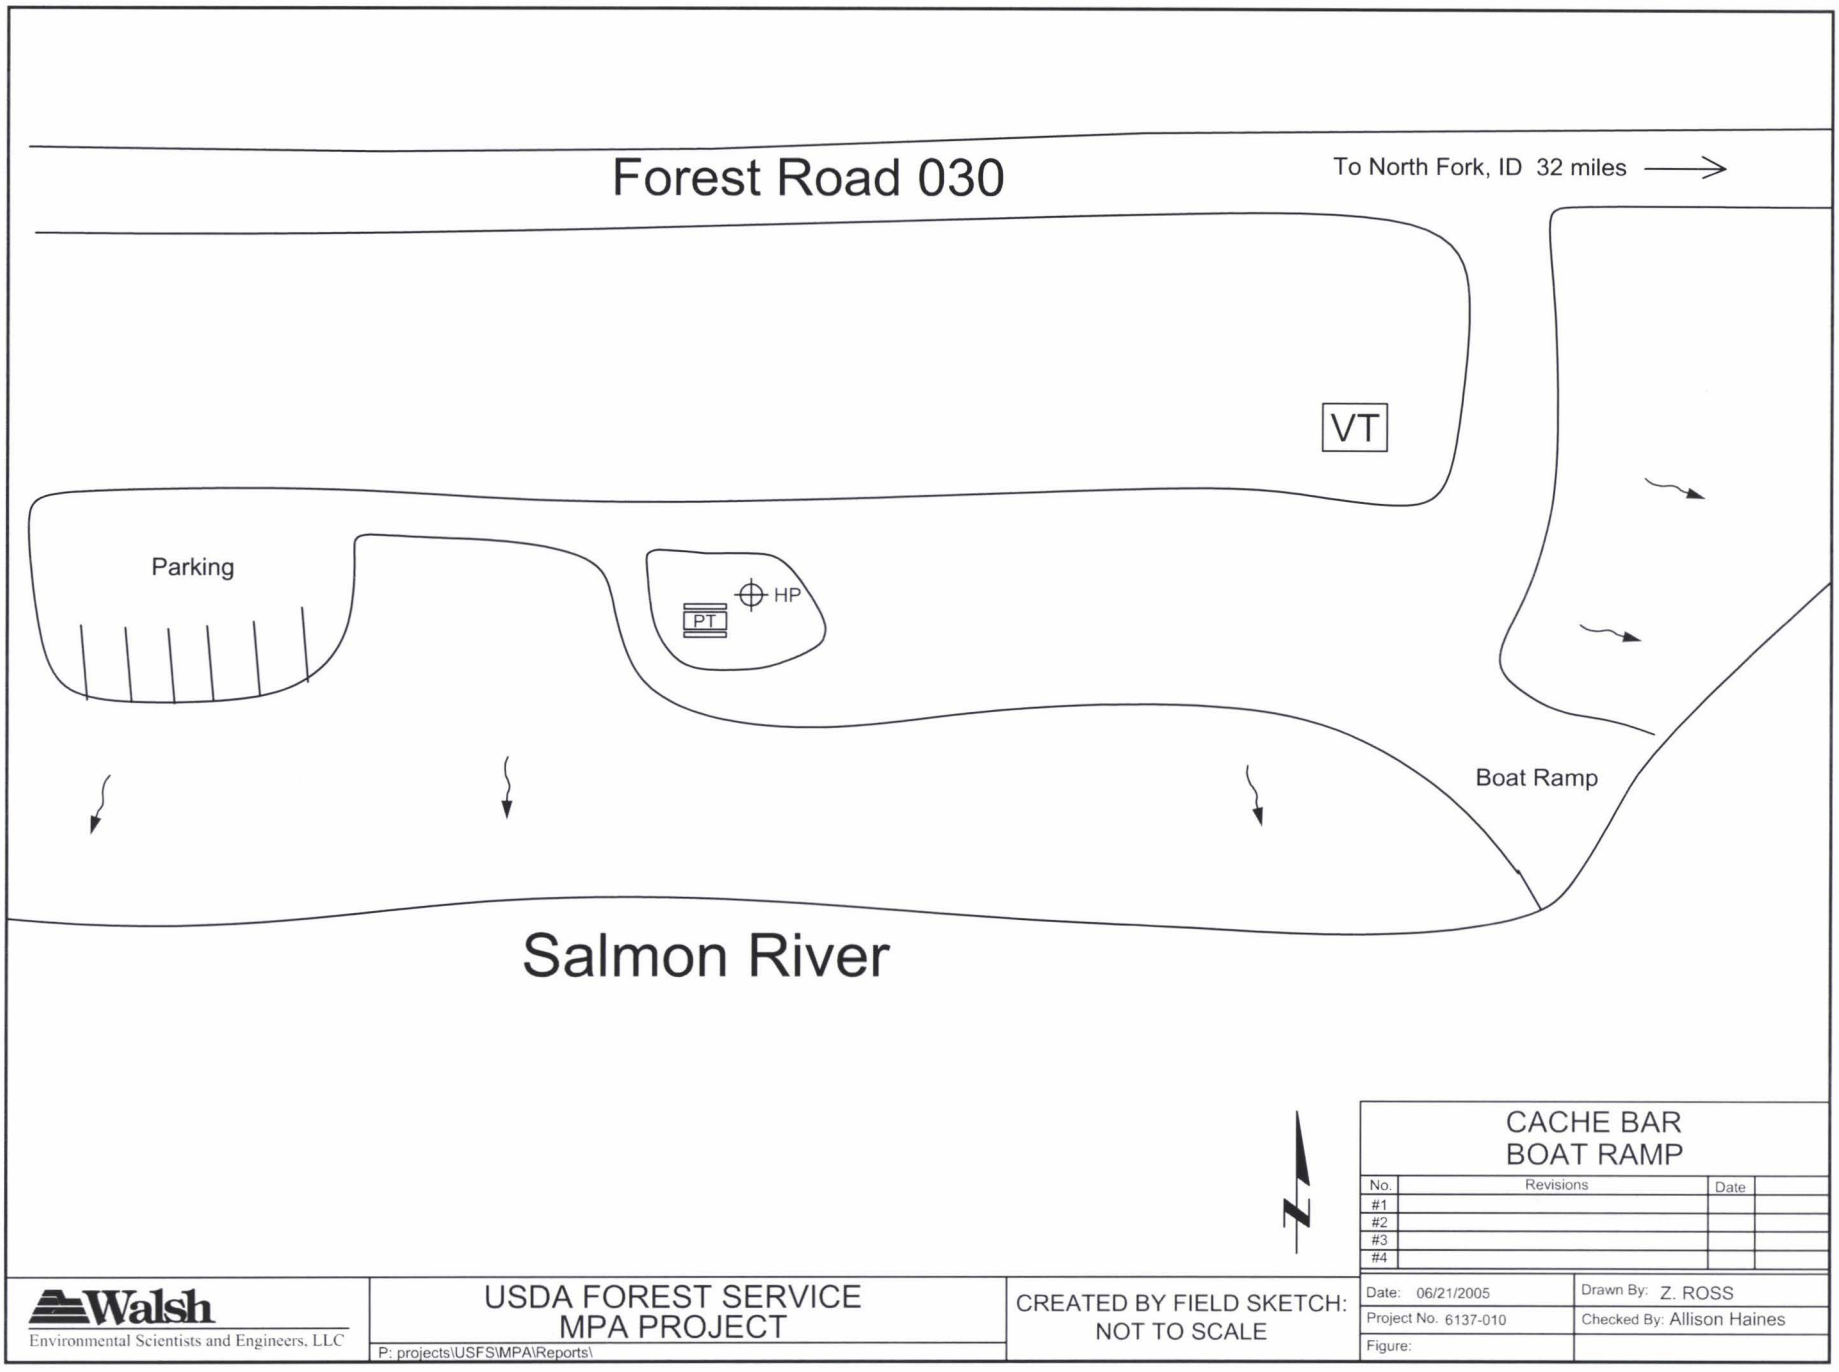
CACHE BAR
BOAT RAMP

The well is in fair condition and appears to have remained unused for some time. The well location is not subject to flooding or pooling. Potential sources of contamination include: Vault toilet located approximately 110 feet northeast and cross gradient of the well and the Salmon River located approximately 150 feet south and down gradient of the well.

Potential Source of Contamination	*Distance (ft)*	*Direction*	*Gradient*
Vault toilet	110 feet	Northeast	Crossgradient
Salmon River	150 feet	South	Downgradient
